LEVEL 1 DOWNSTREAM ANALYSIS

Bristol Lane 9-Lot Plat

Tax Map #192605-9085

March 14, 2016

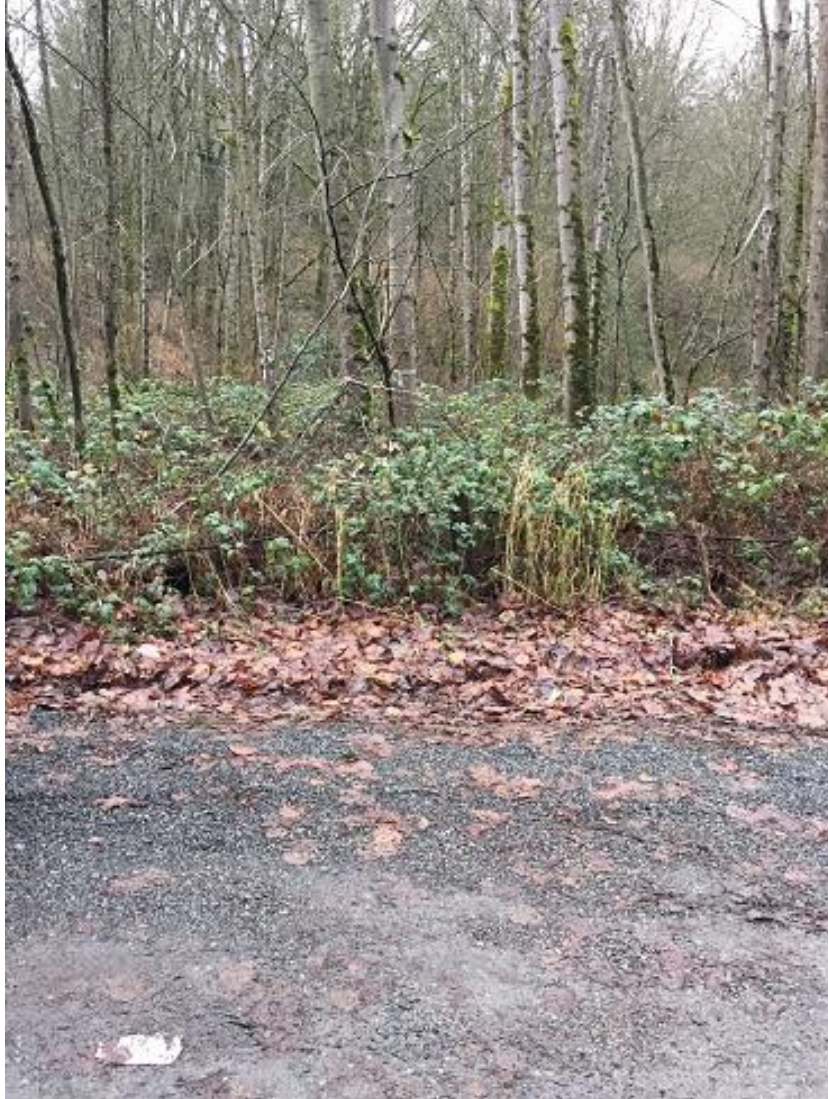
Picture 1: Standing at Simonds Road looking south at subject property (Bristol Lane Plat).

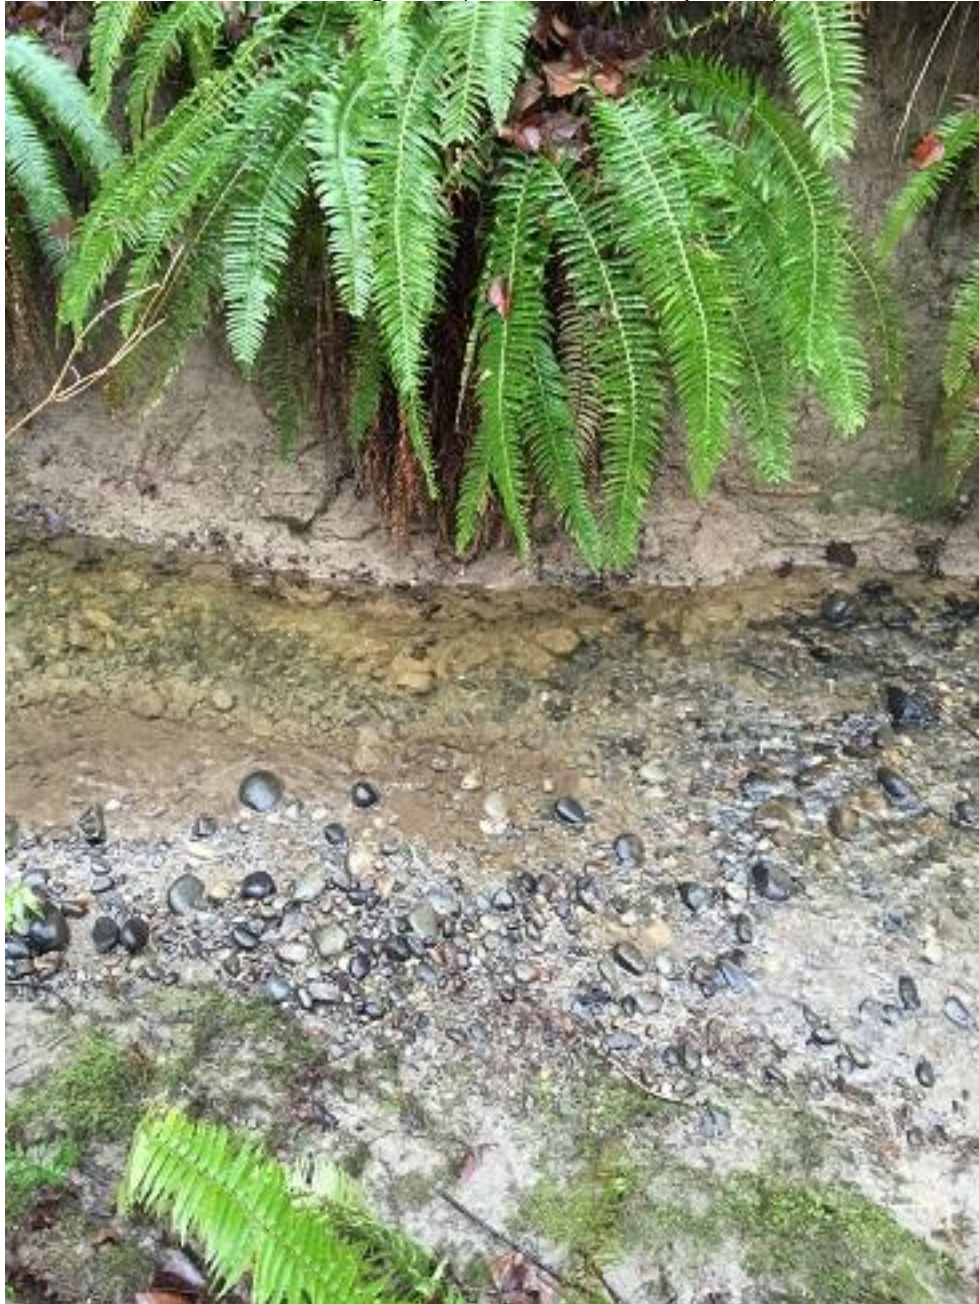
Picture 2: Onsite at Bristol Lane Plat. The Class A Stream (unnamed) at about midpoint of the width of the property. It is rainy season, raining, and there is a few inches of water in the creek at this area. It is flowing east (to the left, in the picture).

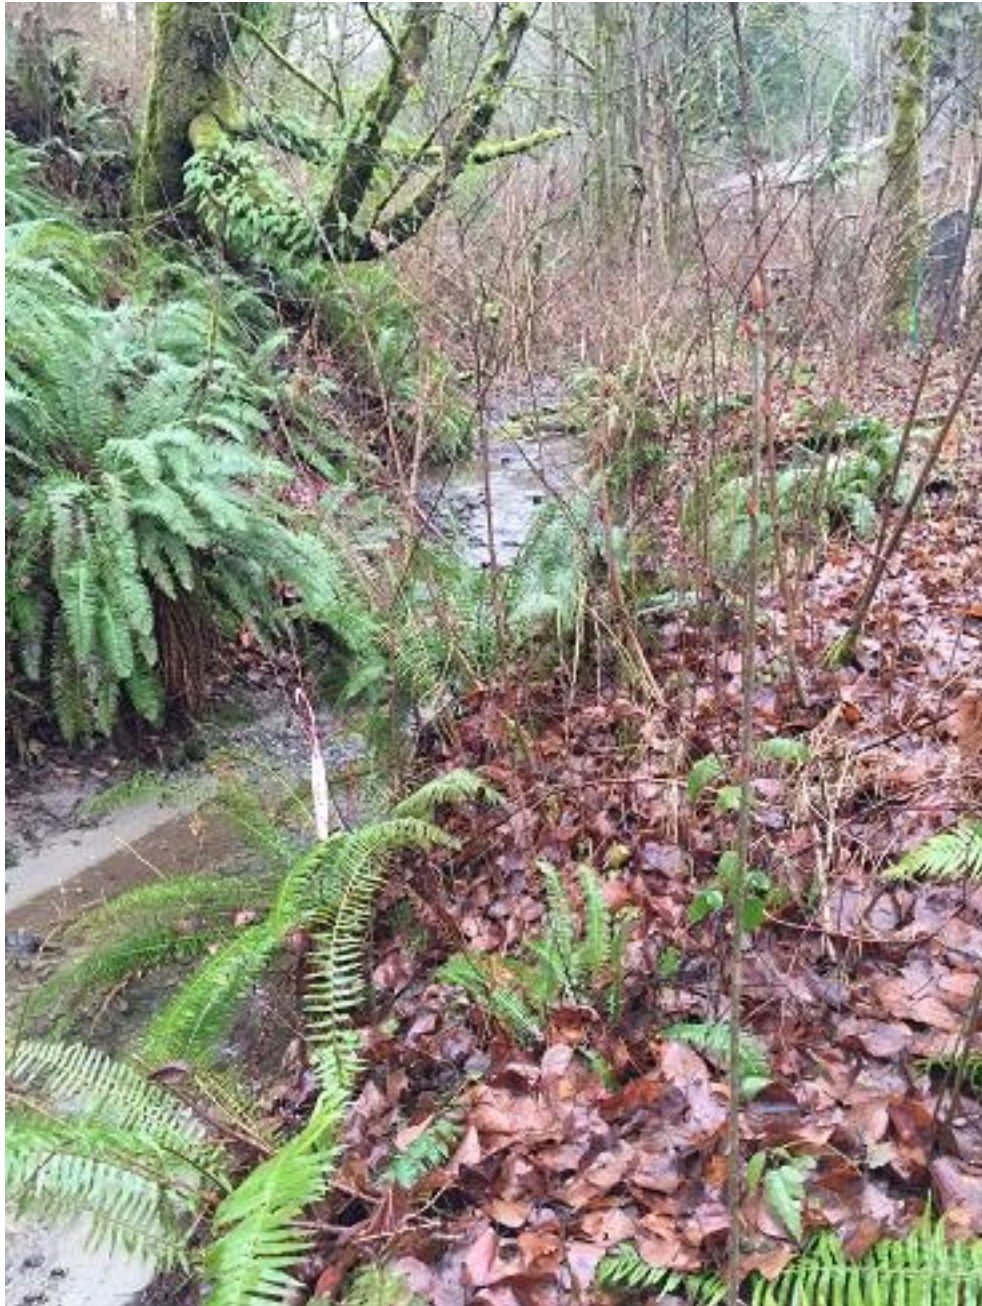
Picture 3: Again onsite at Bristol Lane looking upstream at the Class A Stream.

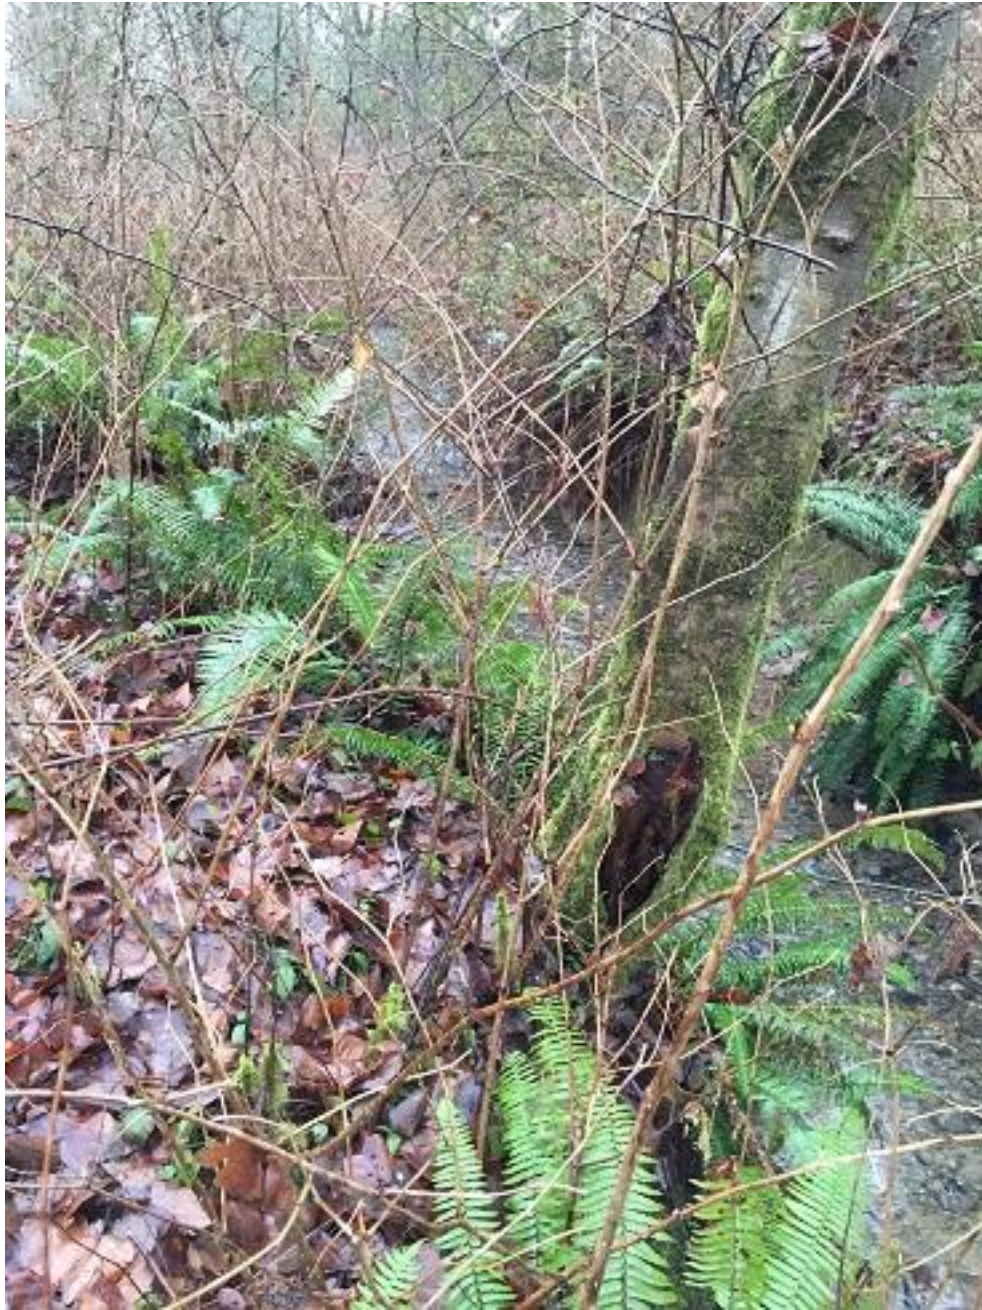
Picture 4: Bristol Lane Site. Standing in the same spot, looking downstream.

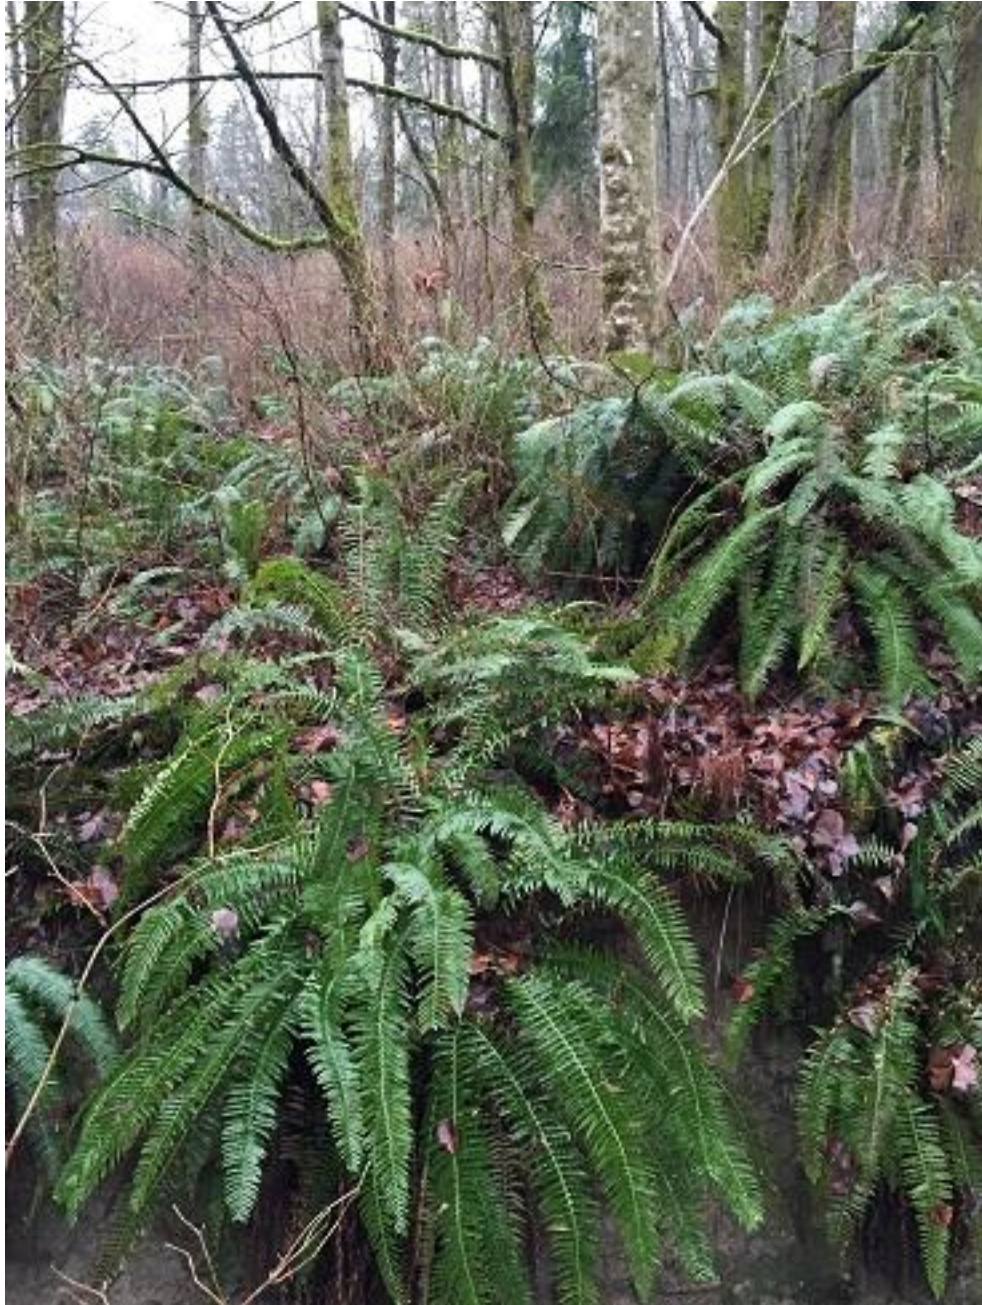
Picture 5: Standing at that same spot, looking north at the steep slope.

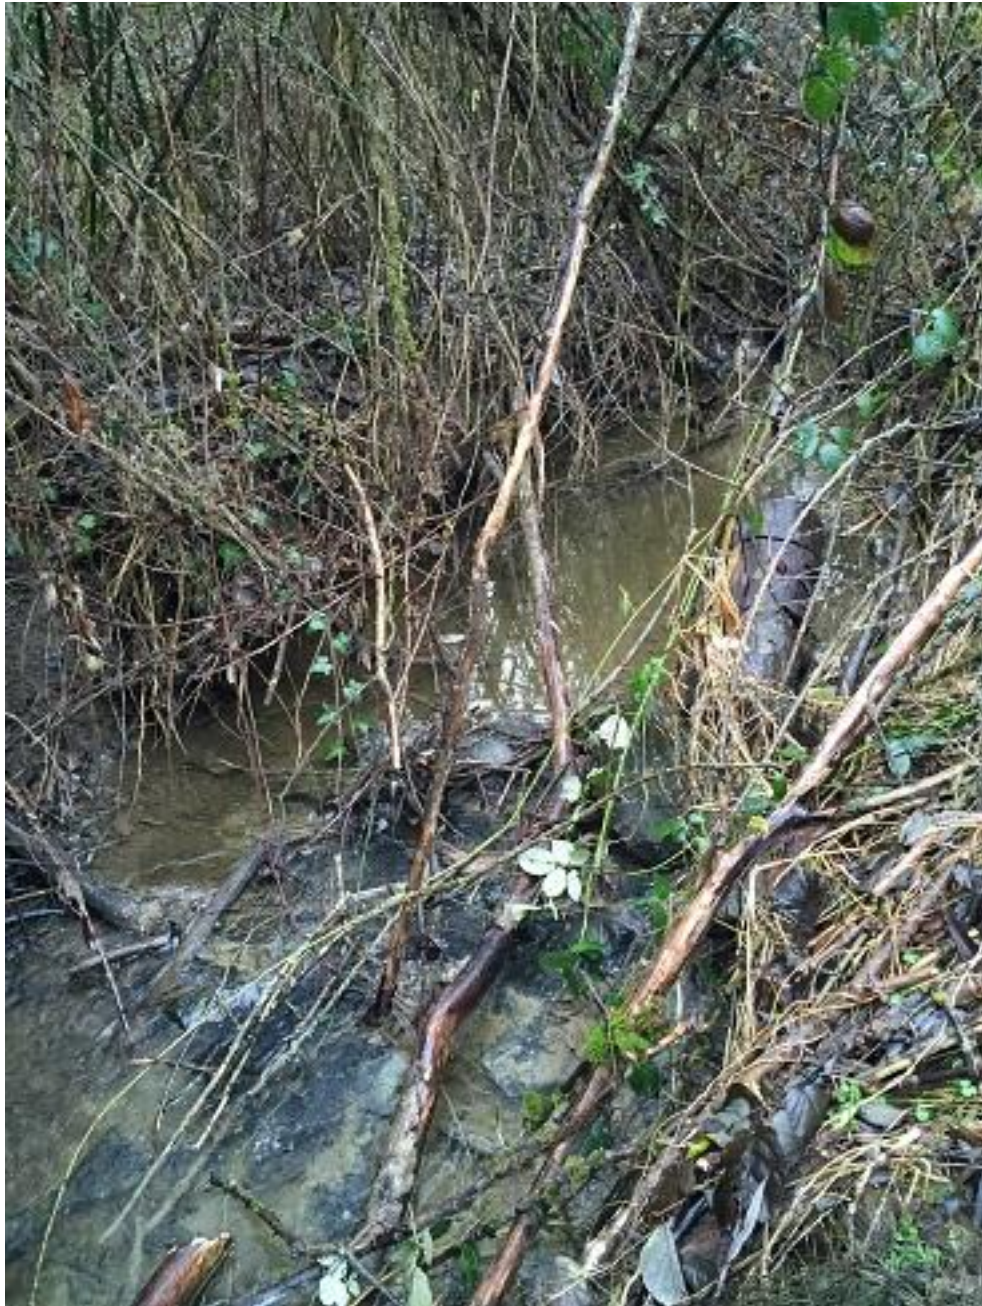
Picture 6: On the western side of 100th Ave NE, looking upstream.

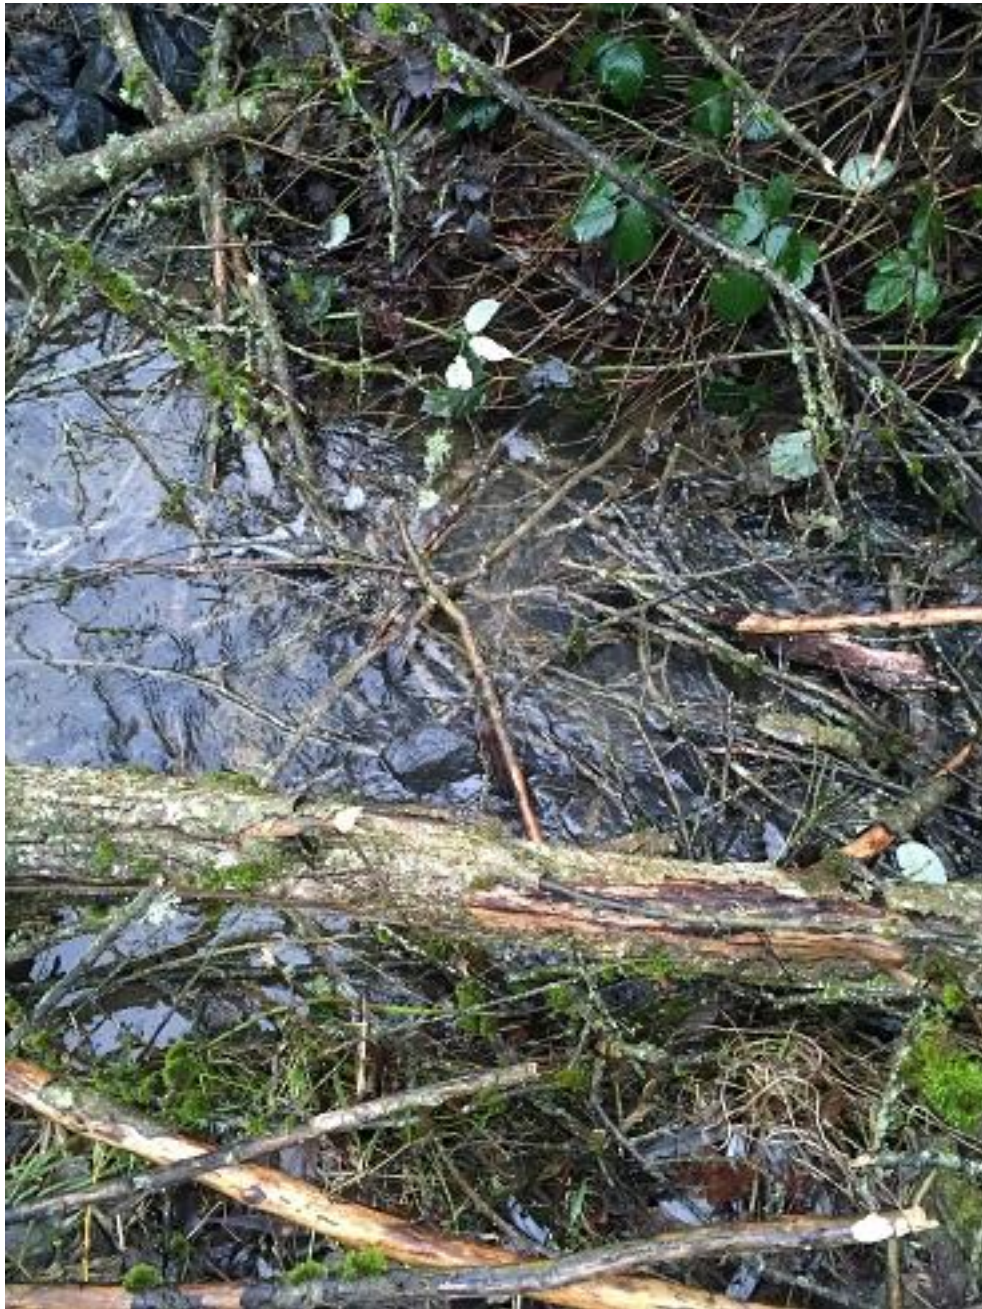
Picture 7: West side of 100th Ave NE. near the control structure prior to crossing under 100th Ave NE. Some debris has accumulated.

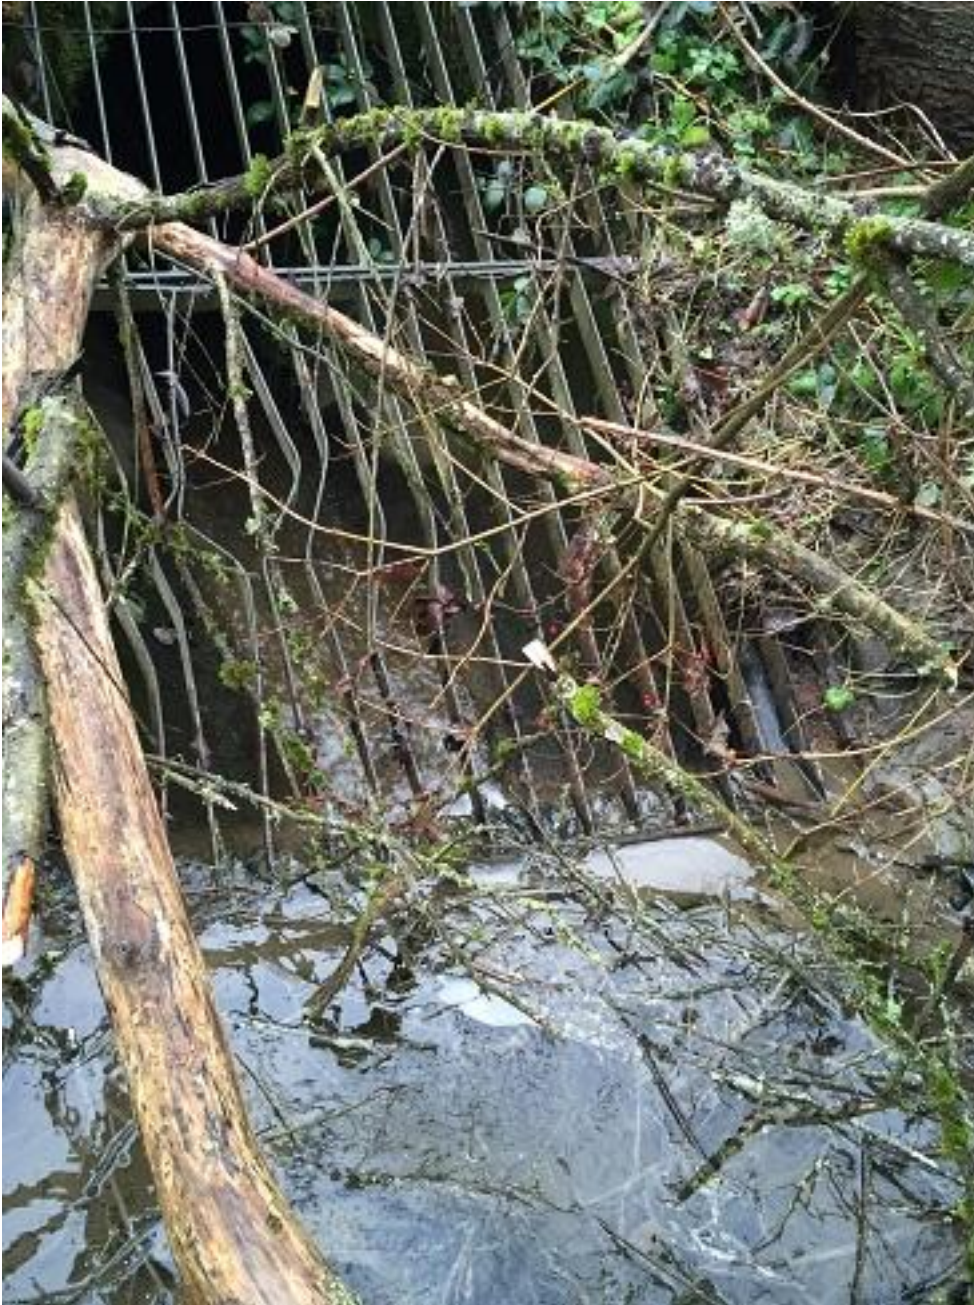
Picture 8: Water flowing eastward into a control structure on eastern side of 100th Ave NE.

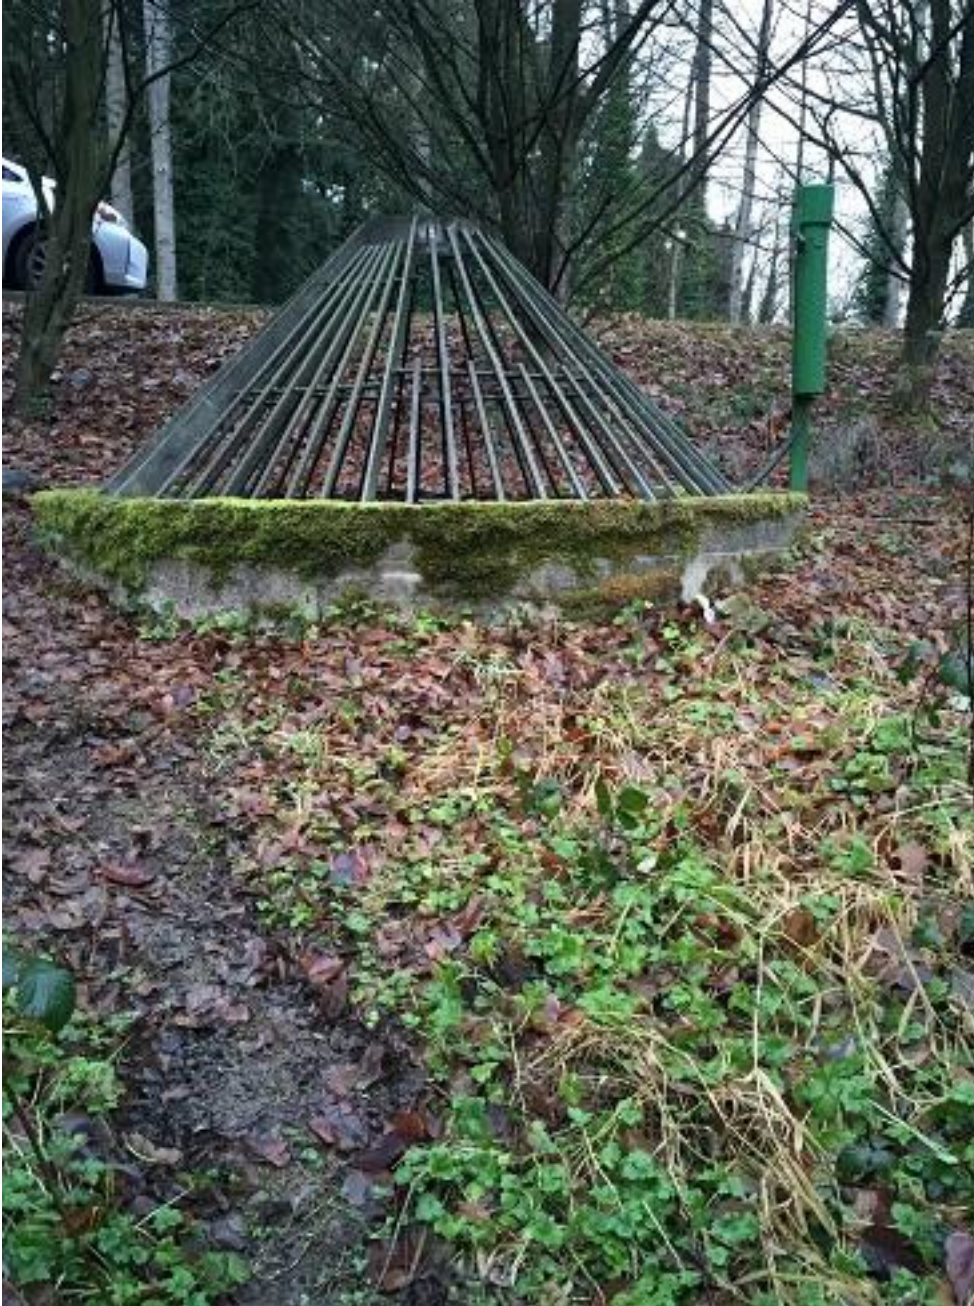
Picture 9: 100th Ave NE Crossing: Overflow Debris cage on top of Control Structure.

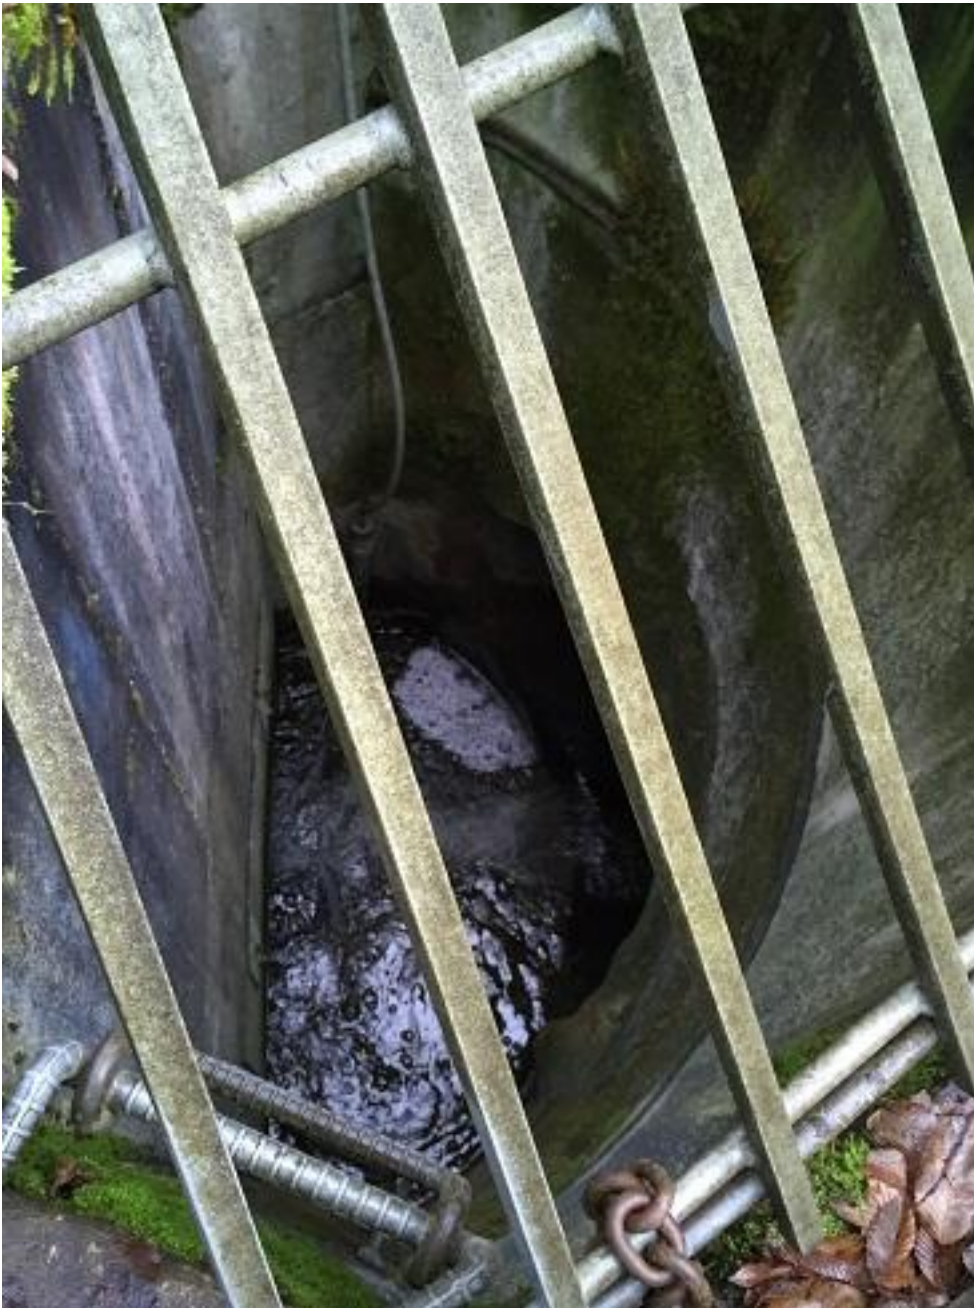
Picture 10: 100th Ave NE Crossing: Looking down into the upstream (incoming) side of the control structure.

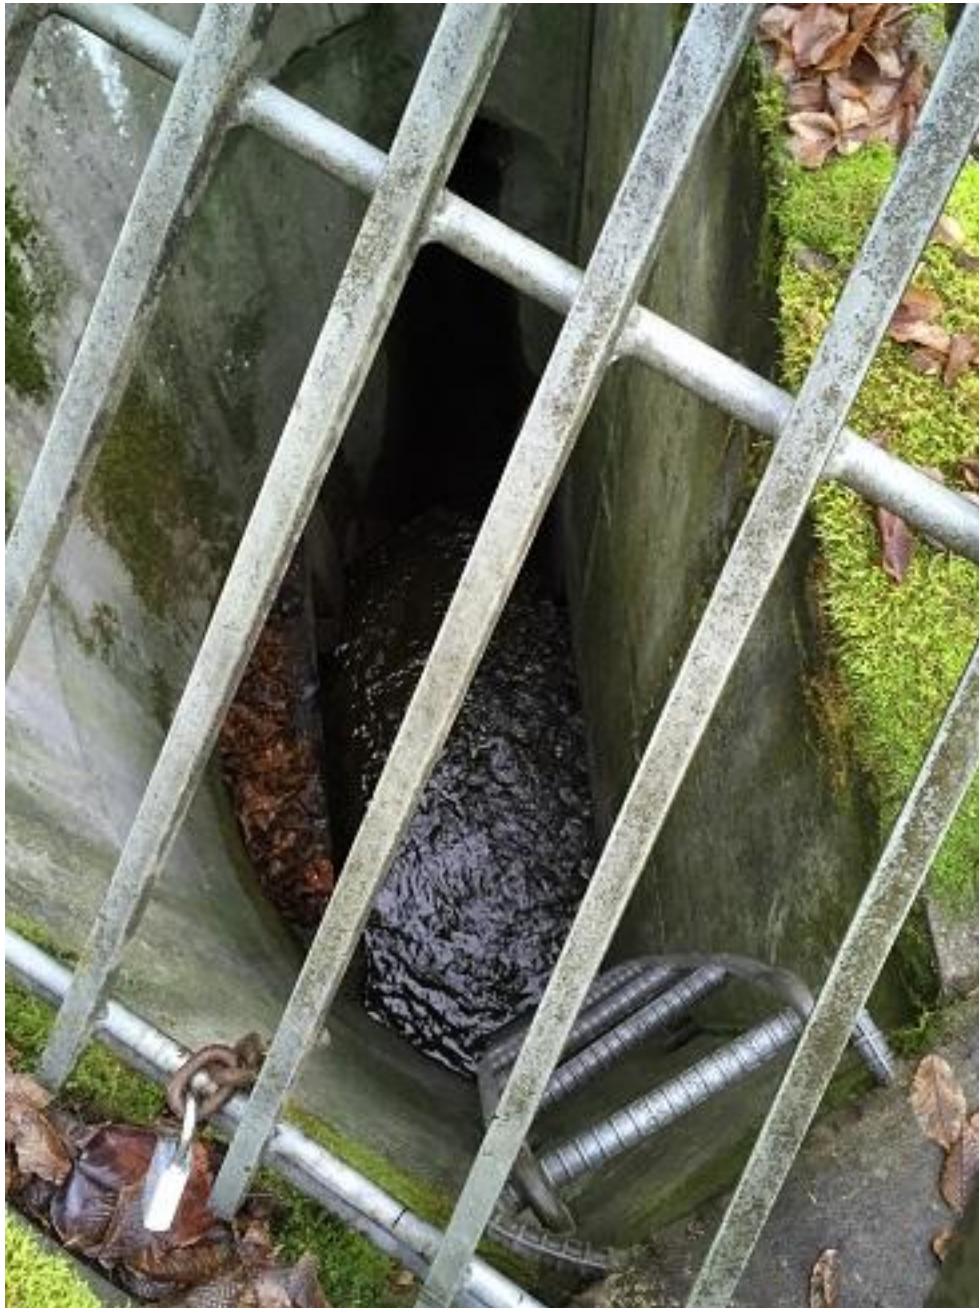
Picture 11: 100th Ave NE Crossing: Looking down into the downstream (outgoing) side of the control structure.

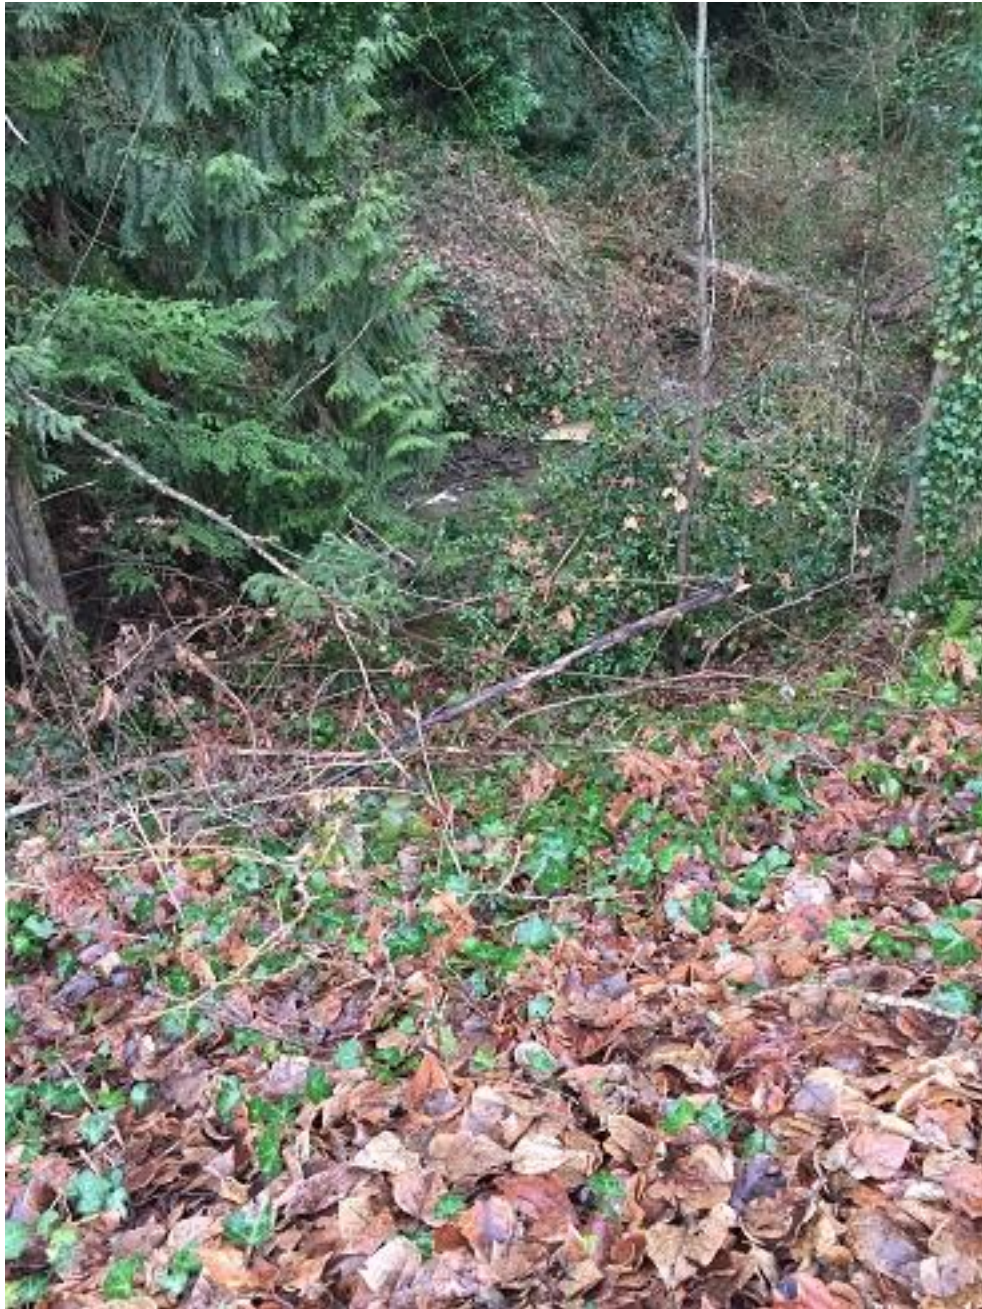
Picture 12: Crossing directly over 100th Ave NE, and looking down to the east.

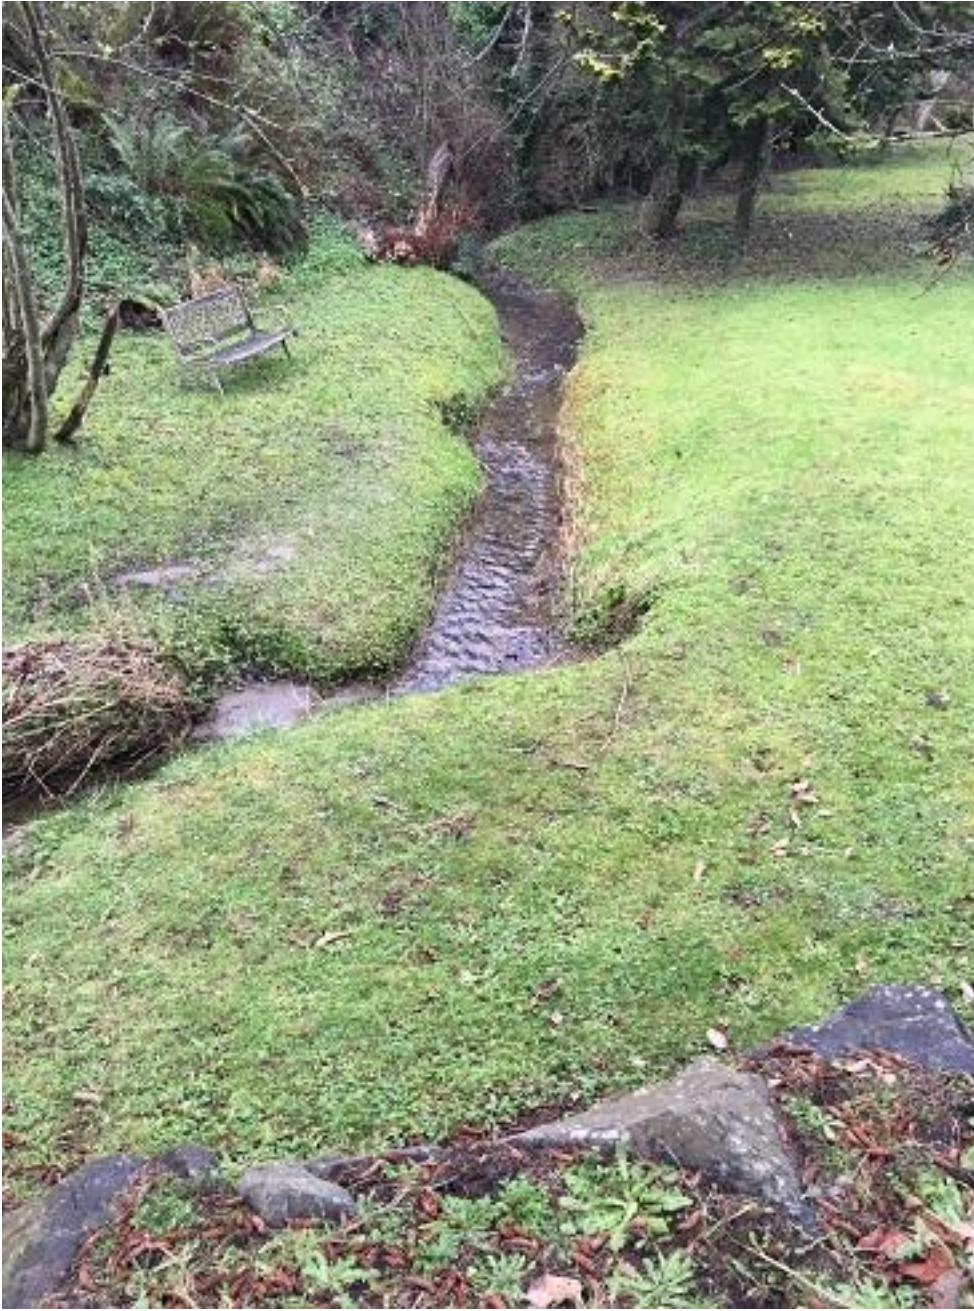
Picture 13: After flowing through private property, the creek again reaches a place I can inspect it, at 101st Place NE. Looks great!
